International Journal of Engineering Science and Innovative Technology (IJESIT)

Seismic Performance of Two Story RC Frames with infill walls

Abstract—This paper presents the results of the experimental and analytical investigations conducted on four 0.8 scale 2-story one bay ductile reinforced concrete (RC) frames with infill nonstructural walls subjected to cyclically increasing loads. The material properties and the member sizes of beams and columns in the four RC frame specimens are identical, but with different types of infill nonstructural wall. These four frames are the pure frame, frame with short column, frame with short beam and frame with wing walls. The four RC frame specimens were designed and constructed according to the general prototype building structures in Taiwan. Test results indicate that the ductility behavior of the frames with infill wall is similar to those of the pure frame. The ultimate base shear strength of the frames with infill walls is higher than those of the pure frame.

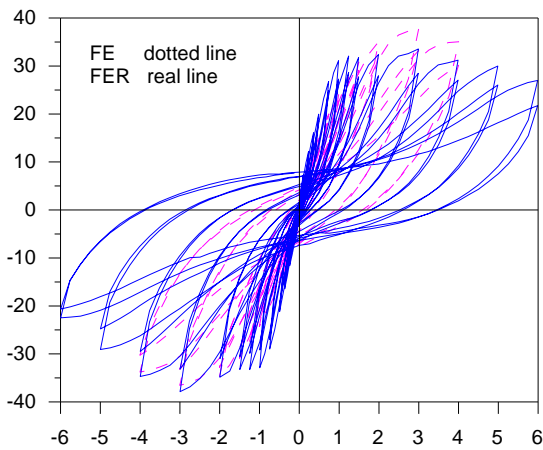
Fig 4. Test responses of specimens FE and FER

Fig. 4 shows the cyclic roof drift ratio versus base shear force relationships for specimen FE and FER. During the testing of specimen FE, concrete cracks developed near the beam-ends and the joint on second floor when a roof drift reached 0.01 radian. When the roof drift reached 0.02 radian, many concrete cracks developed. The crack width has extended to 5mm on the plastic hinging of the beam ends while the unconfined concrete have large cracks and have come off a little bit on the top of the beam of the second floor when the roof drift reached 0.03 radian. At drifts of 4%, the maximum crack width was 10mm, and the unconfined concrete on the beam of second floor have failed (Photo.1). At this time, it was found that the peak lateral strength seemed to have developed and the lateral strength of the specimen have started to drop at 4% drift, so testing procedure was stopped. The maximum base shear was 40 tons at 3% drift. After repaired and retrofitted, the specimen FER was tested again. Because having added wing walls into this frame, the lateral stiffness and strength are better than specimen FE at early stages of the test. When the roof drift reached 1.5%, cracking started to appear at the bottom of the wing wall near the footing, and also, appear at the top of the beam of the second floor. Compared with cracks happened on the top of the beam on specimen FE, cracking on specimen FER did not extend along the whole beam, but along the shorter beam after wing wall was constructed. The crack pattern on specimen FER is the same as specimen FE, except that it is shorter on specimen FER because of wing walls. Moreover, the wing wall failed only at downside near footing, suggesting that it may not develop complete shear strength (Photo 2). The maximum base shear was measured to be 38 tons at -3% drift, similar to specimen FE.

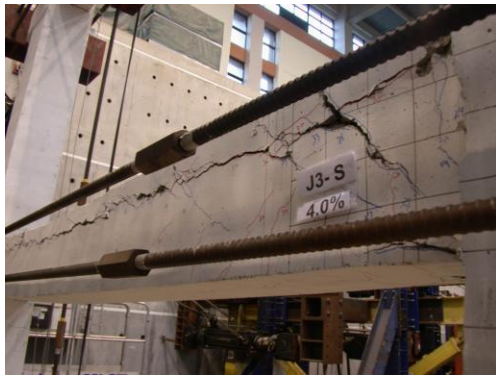
Photo 1. The major cracking on the top of the beam

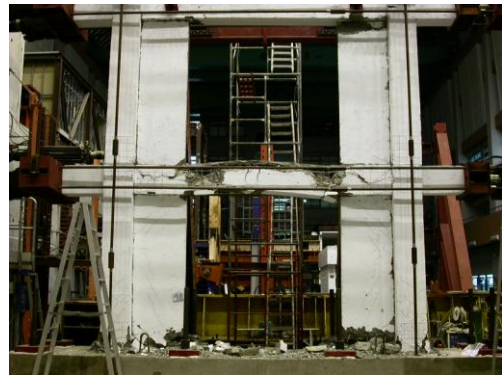
Photo 2. The final failure on specimen FER

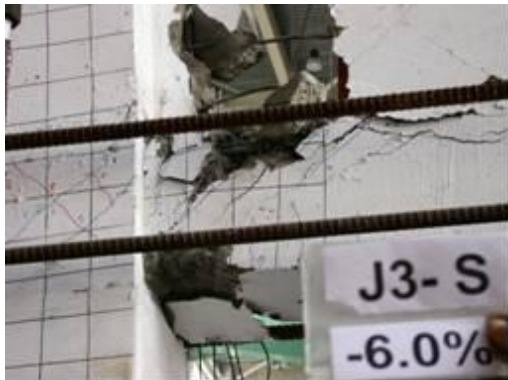
Photo 3. Beam end cracked after wall failed

the column of first floor, and the connection of the infill wall and the column separated a little bit. When the roof drift reached 1%, the crack width of the column plastic hinging was 0.7 mm, the shear crack width on the wall was 2.5 mm and the gap between column and wall was 5 mm. After 1.5% drift, there were many cracks starting to appear more on short column regions. At 3% drift, the major cracking happened on the wall at the connection of the column and the wall. The test stopped at 4% drift when the strength of the specimen started to drop. The base shear strength of 60 tons appeared at 1.5% drift. The test proceeded again after repairing the cracks using the cement mortar and epoxy, and putting on steel jackets on short column regions. The lateral stiffness and strength of specimen SCFER at early stages of the test were shown to have much decline than those of specimen SCFE. Cracking initially happened on walls at the connection of the column and the wall, just like specimen SCFE but more severely, and then continued extending at the bottom of the column due to the effect of steel jackets on short column regions. At 5% drift when the wall has failed, it acted just like a pure frame (Photo 3), and the testing stopped at 7% drift. The maximum base shear was 50 tons at 3% drift.

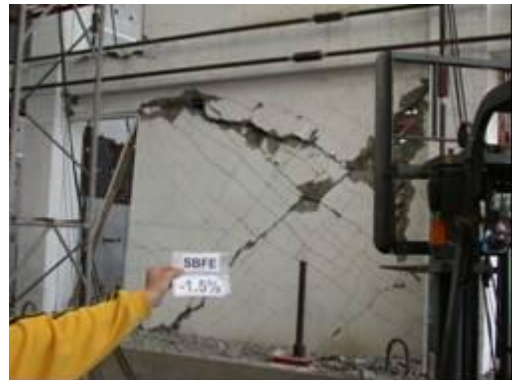
Photo 4. The wall damaged severely at 1.5% drift

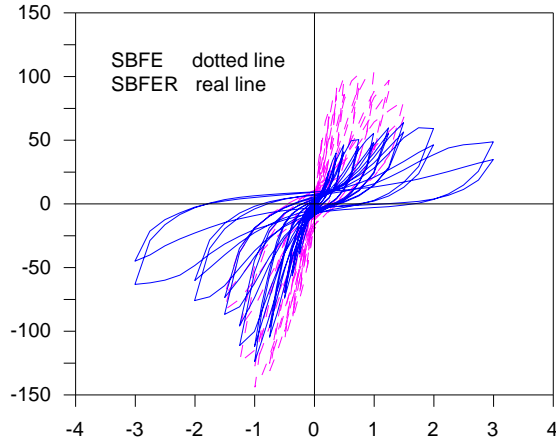
Fig 6. Test responses of specimens SBFE and SBFER

Fig. 6 shows the relationship between the base shear and roof drift. At 0.25% drift, there were several parallel cracks appeared on the column, and some shear cracks, the width of 0.9mm, on wall. At 0.5% drift, cracking happened on short beam region over the opening, a door, and so did on joint near the opening side. Also, the crack width of 2mm was measured on wall. As the roof drift reached 1% drift, many cracks developed on the region over the opening and on the wall as well. The crack width on the wall was 6.6mm. In addition, some small concrete pieces had started to drop. When the roof drift reached 1.5%, the infill wall damaged severely; however, the frame just slightly injured, especially on the short beam region (Photo 4). The maximum base shear strength was 144 tons at 1% drift. Similarly, because the base shear had dropped, the test was stopped. After repairing, specimen SBFER proceeded to another test. Because of un-symmetry on the specimen, the unbalanced strength was even more obvious on specimen SBFER than on specimen SBFE, the specimen before repaired. The failed region was similar to specimen SBFE. After testing, the frame without the infill wall was still in a moderate shape. The base shear

strength of 124 tons, slightly lower than specimen SBFE of 144 tons, both happened at 1% drift.

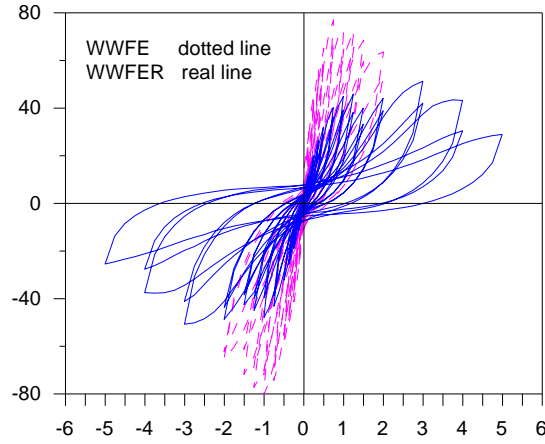
Fig 7. Test responses of specimens WWFE and WWFER

The base shear and roof drift relationship are shown in Fig. 7. At 0.5% drift, cracking started to appear at the bottom of column plastic hinging and near the corner of the opening of the wall. The crack width was 1 mm and 4 mm, respectively. When the roof drift reached 1%, cracking gradually became large at both corners of the openings of the wall. The reinforced bar inside the wall could be seen due to failed concrete on the wall at 1.25% drift. The wall deteriorated as the roof drift became larger. In addition, there were cracks developed along the top of the beam. The test stopped at 2% drift (Photo 5), and the maximum base shear strength was 80 tons measured at 1% drift. Like other specimens, specimen WWFER, the repaired specimen WWFE, was tested again after simple repair procedures had been done. At early stages of the test, the lateral stiffness and strength of specimen WWFER had much difference compared with original WWFE. The cracks happened mainly at the same positions where the cracks happened before on the walls. Also, according to its hysteretic loops, it acted just like a frame without infill walls (Photo 6). The strength gradually developed to its maximum level, 51 tons at 3 % drift. At last, the test stopped at 5% drift.

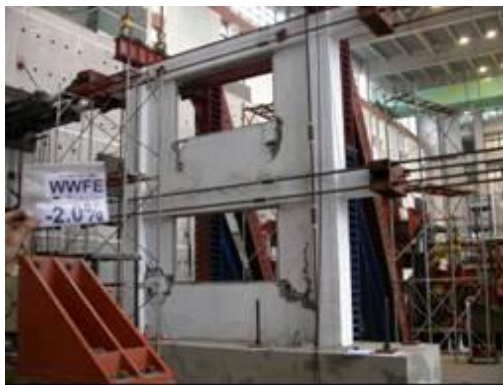
Photo 5. Cracking happened at the corner of the walls

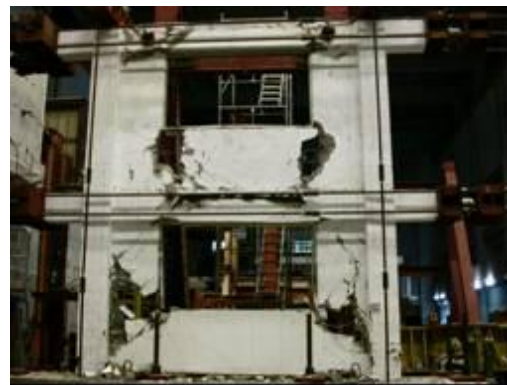
Photo 6. Specimen WWFER acted like a frame after wall failed
