International Journal of Engineering Science and Innovative Technology (IJESIT)  
Volume 8, Issue 2, March 2019

# Debonding Failure of Externally Bonded GFRP Sheet on Flexural Strengthening of Reinforced Concrete Beams

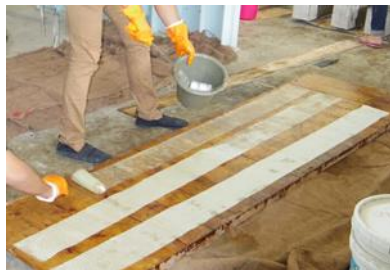
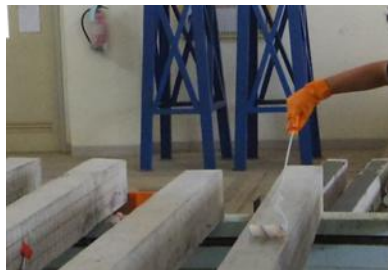
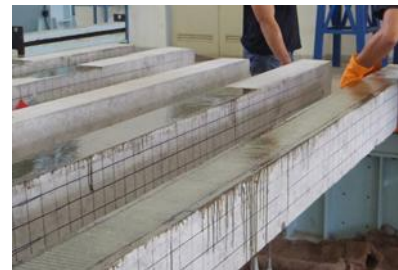
**Fig. 2: GFRP Application**

The longitudinal GFRP sheets were bonded to the bottom face of the beams oriented to the beam axis by a wet-layup procedure. The U-shaped anchorage sheet was bonded in the transverse direction of the beam with the same method. The U-shaped anchorage sheet aims to prevent the sheet end failure in the non-tested span. The fabrication procedures as follow: First, the concrete surfaces were slightly polished to make them smooth and remove the degradation layer. Then, a surface primer was applied (**Fig. 2(a)**). After that, a GFRP sheet was bonded to the concrete surface by impregnating and hardening with the epoxy resin (**Figs. 2(b)** and **(c)**). The air bubbles between the concrete surface and GFRP sheet were removed by roller brushes. Finally, a coat layer of impregnating resin was pasted. The specimens were cured in room temperature for at least three days before the loading test.

a. Applying epoxy to GFRP

b. Impregnation of epoxy

c. Bonding GFRP to concrete

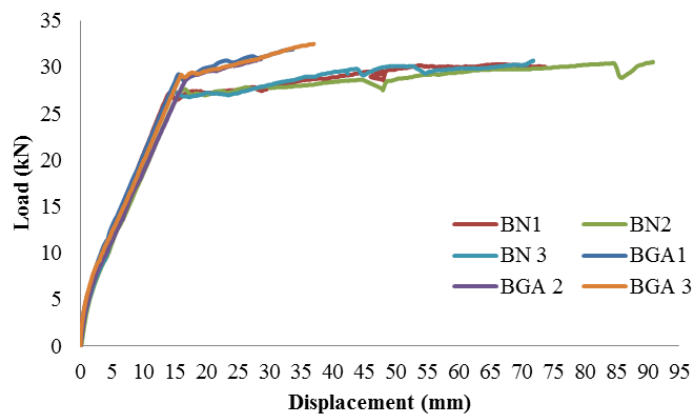
**Fig. 6: Load-displacement curves**

Figure 6 shows the load-displacement curves. As can be seen, the normal beams (BN1, BN2 and BN3) showed a similar behavior with the strengthened beams (BGA1, BGA2 and BGA3) until the yielding load. Beyond the yielding load, the stiffness of strengthened beam was stiffer than the normal one. Thus, by using the GFRP sheet on the bottom of the beams, the post-yielding flexural stiffness of the strengthened beams was significantly enhanced from that of the normal beam.

**Table 2** summarizes the maximum load and displacement for all beams. The displacement reported here was the displacement at the midspan of the beam. From **Table 2**, it was seen that the average maximum load and displacement in the normal beam (BN) was 30.04 kN and 73.74 mm, respectively. Meanwhile the average maximum load and displacement in the strengthened beam (BGA) was 30.04 kN and 73.74 mm, respectively. The results indicated that the GFRP sheet decreased the mid-span deflection of the beam.

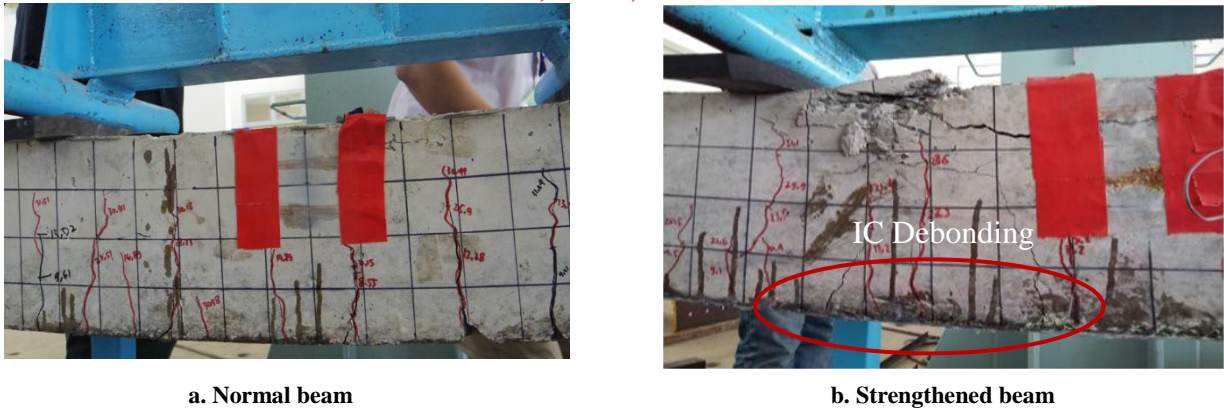
Fig. 9: Failure pattern

The normal beam failed in flexure, while the strengthened beam failed by debonding as shown in **Figs. 9(a)** and **(b)**, respectively. The failure behaviors of the strengthened beams were explained by an interfacial stress model<sup>(6), 7)</sup> introduced in **Fig. 10**. The stress acting in a concrete element near the interface between concrete and bonded sheets consist of interfacial shear stress ( $\tau$ ), interfacial normal stress ( $\sigma_y$ ), and tensile stress ( $\sigma_x$ ). The tensile stress at the bottom of the concrete section is due to a bending moment at a considered section. Meanwhile the interfacial stresses show the high concentration at the end of the bonded sheets due to the discontinuity in flexural stiffness. The debonding of the bonded sheets is initiated when the principal stress, which is the combination of three stress components, exceeds the strength of the weakest element. Final debonding was initiated by local debonding on the critical bonding stress location.

Figure 9 shows the relationship between the load and tensile strain in the bonded sheet. It was seen that the measured the tensile strain in the bonded sheet at the peak load for BGA1, BGA2 and BGA3 was  $5471 \mu\epsilon$ ,  $6397 \mu\epsilon$ , and  $7454 \mu\epsilon$ , respectively. These values were smaller than the ultimate strain ( $\epsilon_{fu}$ ) of GFRP sheet (equal to  $20000 \mu\epsilon$ ). This indicated that the premature failure occurred at the strengthened beams due to the debonding of the GFRP sheet (Fig. 9(b)).
